HOUSATONIC RIVER BASIN,
DANBURY, CONNECTICUT.

WEST LAKE RESERVOIR DAM
(CT 00070)

PHASE I INSPECTION REPORT
NATIONAL DAM INSPECTION PROGRAM

JULY 1980

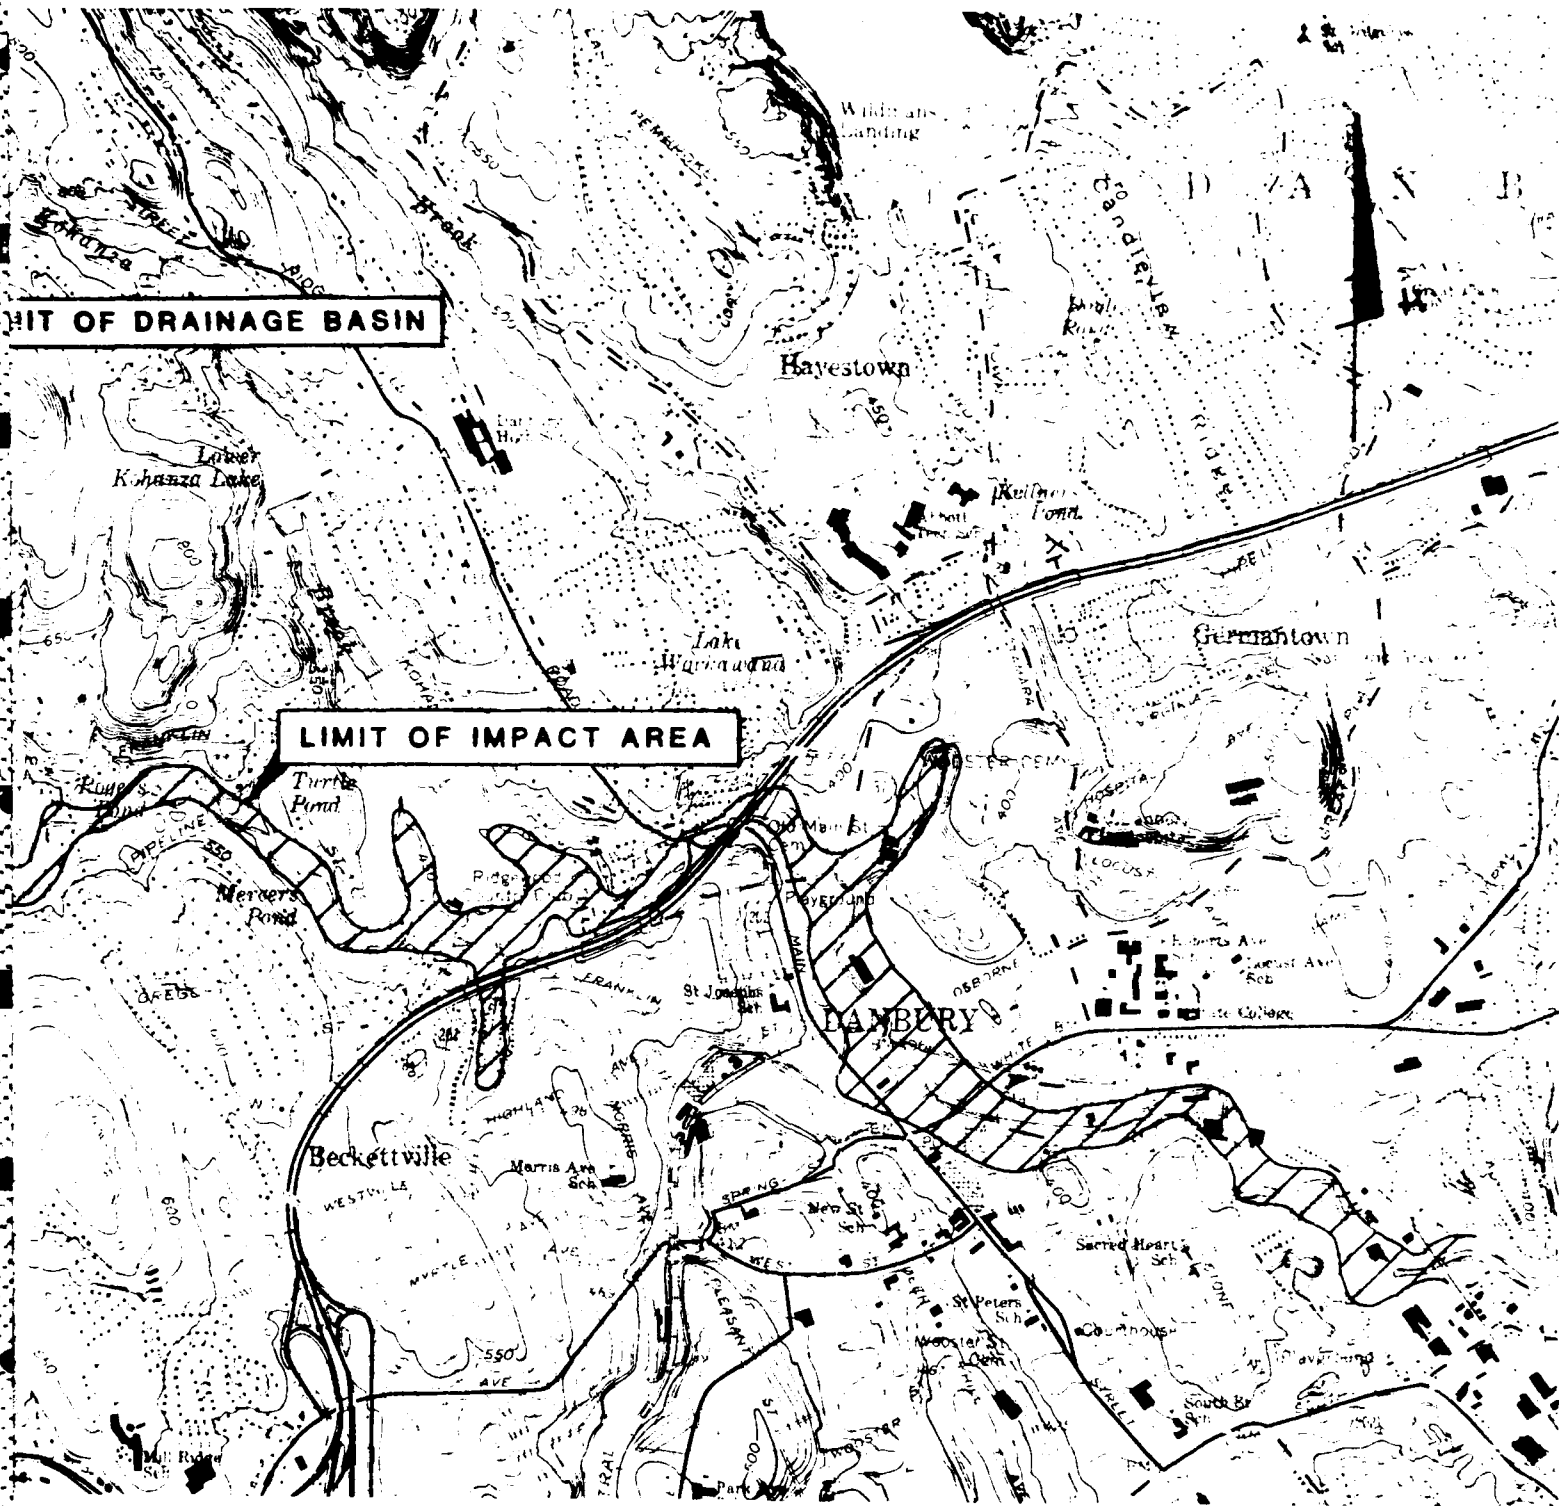
PLATE 3

a. **Drainage Area** - The West Lake Reservoir drainage basin is in the City of Danbury and is irregular in shape. The area of the drainage basin is 3.3 square miles (Appendix D - Plate 3). Approximately 10 percent of the drainage basin is natural storage and more than 50 percent is undeveloped. The topography is rolling with elevations ranging from 1,067 (NGVD) to 611 (NGVD) at the spillway crest.
